BUILDING SCIENCE SERIES 40

Engineering Aspects of the 1971 San Fernando Earthquake

This report presents the observations of the NBS on-site inspection team (most photographs in this report were taken by the team). The material presented herein is intended to serve as (1) a documentation of damage resulting from the earthquake and (2) as a source document for further studies, research, and recommendations. This is particularly important as necessary remedial work and restoration have resulted in the removal of evidence that is essential for studies and evaluations.

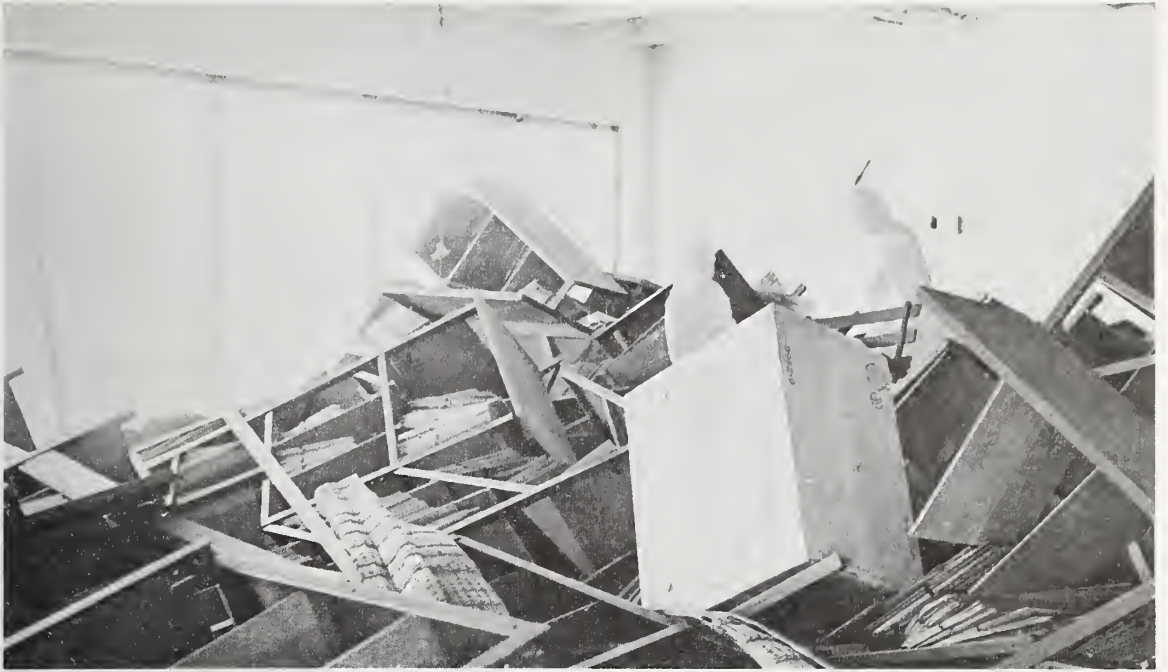
Limited wall cracking was found in the basement and more pronounced wall cracking was found in the first- and second-stories. Structural damage was not severe above the fourth story although some did occur as shown in the photograph of a doorway on the seventh story in figure 5.70. Shaking on the seventh floor also caused shelves to overturn, dumping their contents on the floor (figure 5.71).

Figure 5.71 Shaking caused shelves to overturn on the seventh floor.

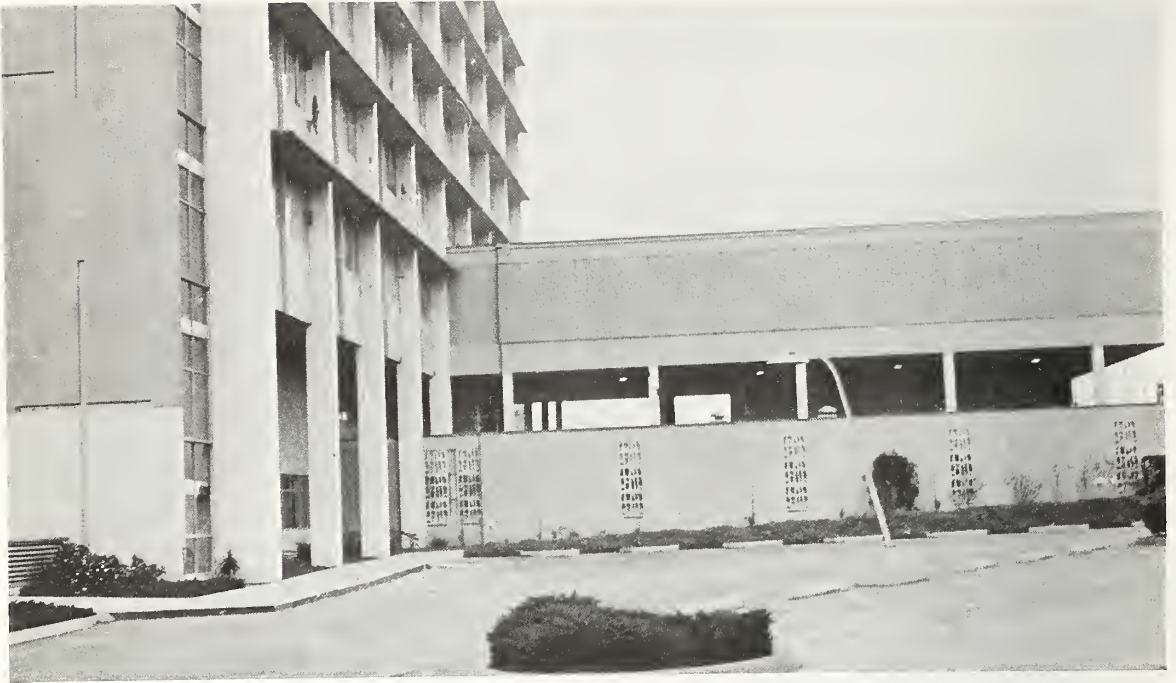
The three-story north appendage, referred to as the north wing, is shown in figures 5.72 and 5.73. Note the portion of the wing supported on the second-story columns and attached to the third and fourth floors of the tower section. It was probably this configuration which caused the extensive damage to the third and fourth stories of the seven-story tower. The second-story columns shown in the east elevation were cracked as shown in figures 5.74 and 5.75. The north wing has now separated from the tower by cracking which occurred at the juncture of the wing and the tower.

Figure 5.73 East elevation of three-story north wing. The east row of the second-story columns are shown in figure 5.74.

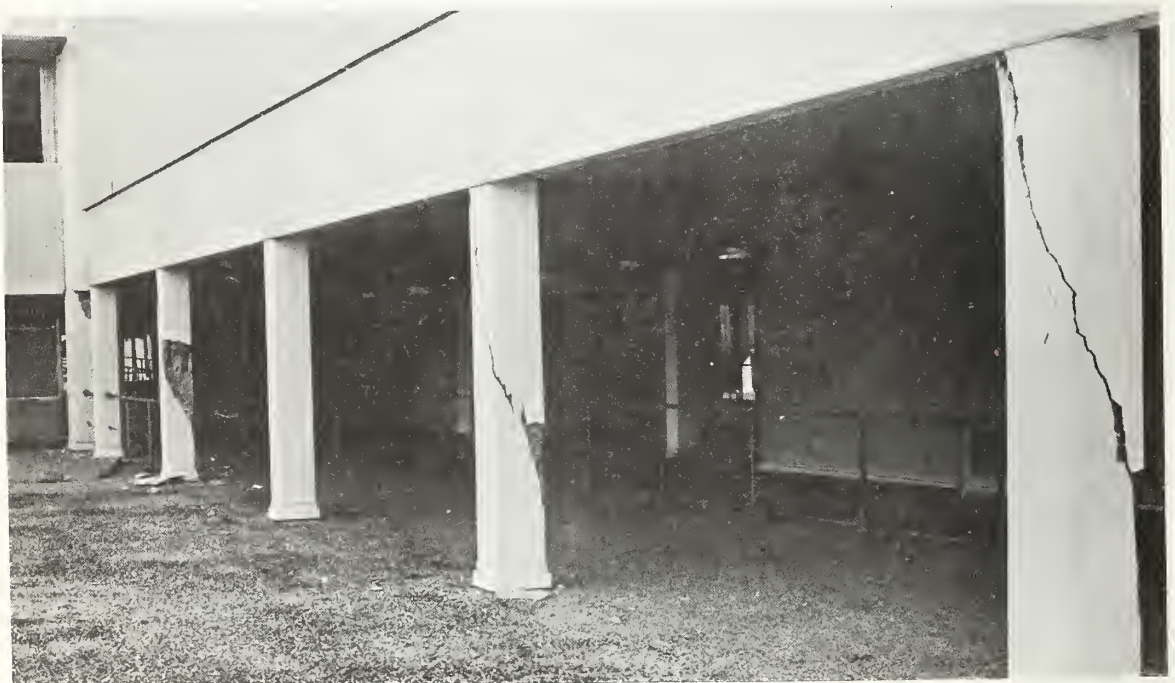
Figure 5.74 Torsional cracking of second-story columns in the north wing.

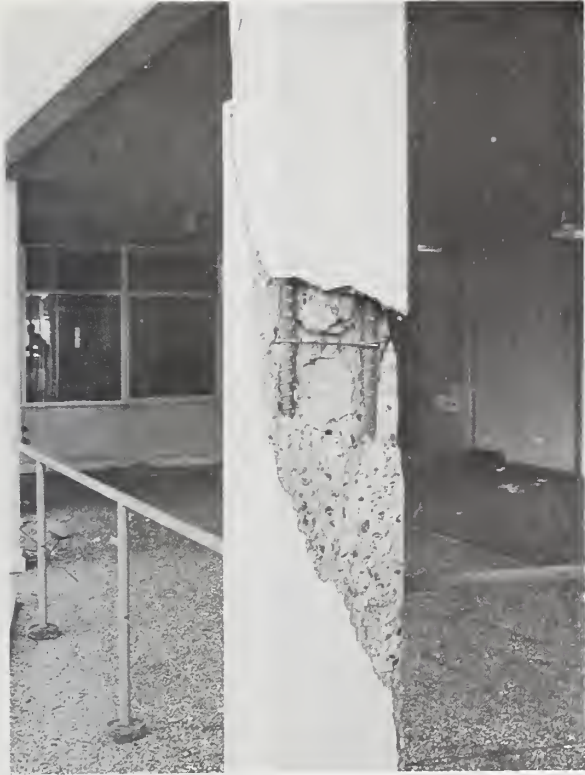
Figure 5.75 Close-up view of one of the columns shown in figure 5.74

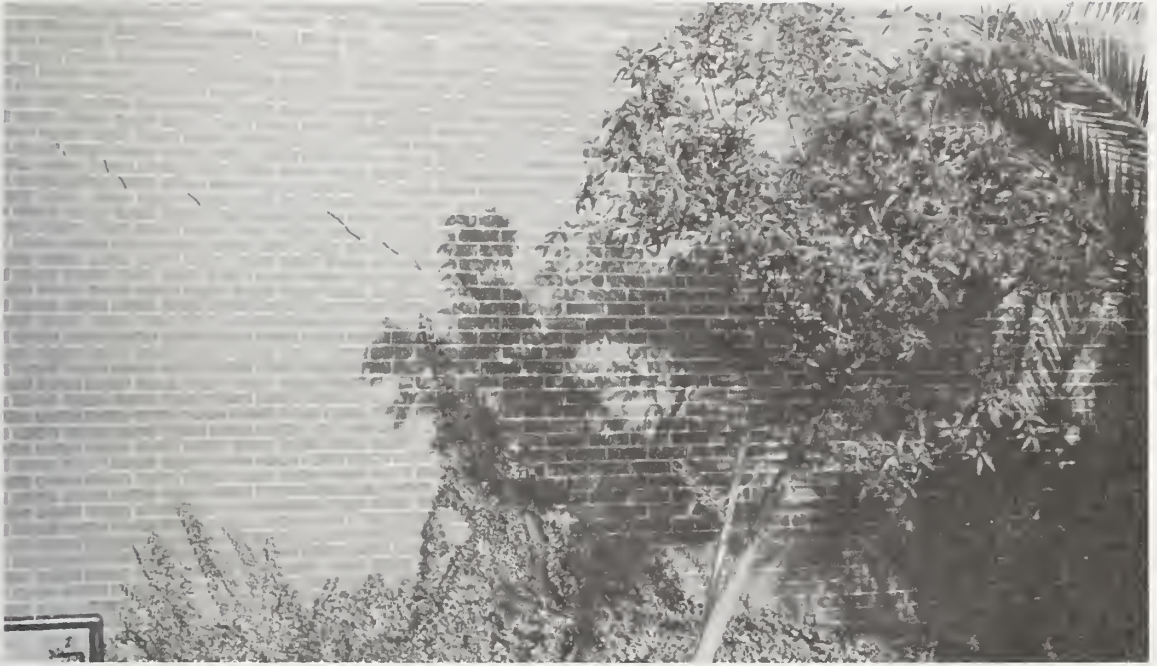
The building consists of three sections. The three story plus basement center section, the one- and two-story north section, and a one-story south section (figs. 5.77 and 5.78). A south elevation of the center section which shows the basement is shown in figure 5.79. A portion of the south section is barely visible behind the trees in the right of the figure. The reinforced brick wall behind the trees was cracked diagonally as shown in figure 5.80. This was the west wall of the cafeteria.

Figure 5.80 Reinforced brick masonry shear wall at west end of south section.

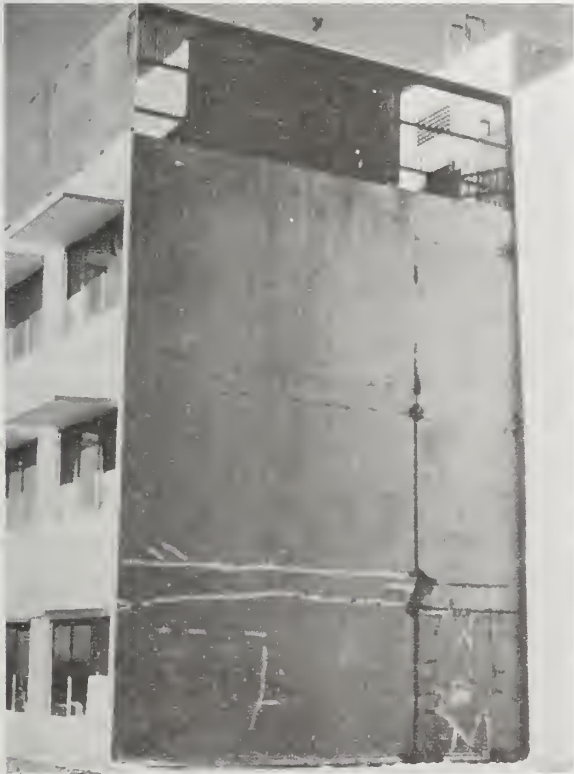
The east-end shear wall, a major load resisting element, was badly damaged as shown in figure 5.81. The portion of the walls outlined by a distinct rectangular crack pattern at each of three stories are referred to as "knockout panels" on the structural drawings. They were apparently provided for future expansion. An interior view of the first-story shear wall is shown in figure 5.82.

Figure 5.81 East-end shear wall of center section.

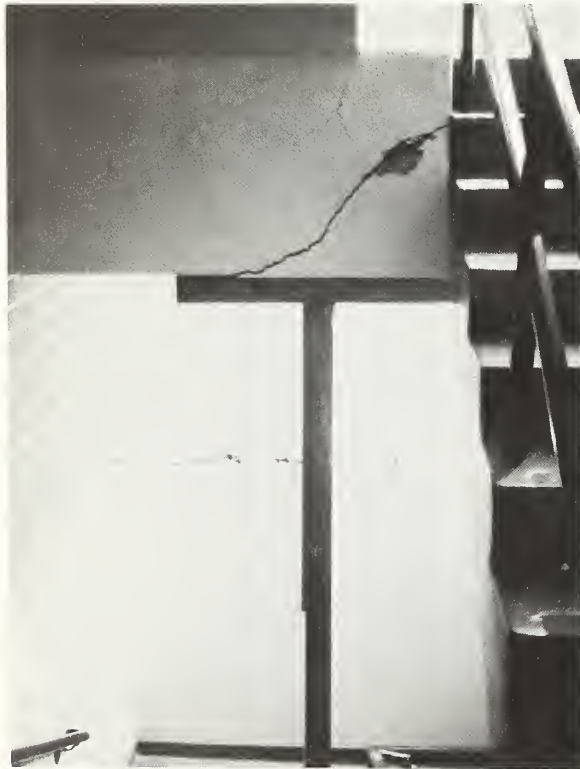
The stairwell shown in figure 5.83 was located at the east end of the center section and was damaged extensively. One of the two elevators (shown in figure 5.84) was badly distorted and inoperative. The second elevator was functioning.

Figure 5.83 Damaged reinforced concrete beam and walls in the stairwell at the east end of Pacoima Hospital.

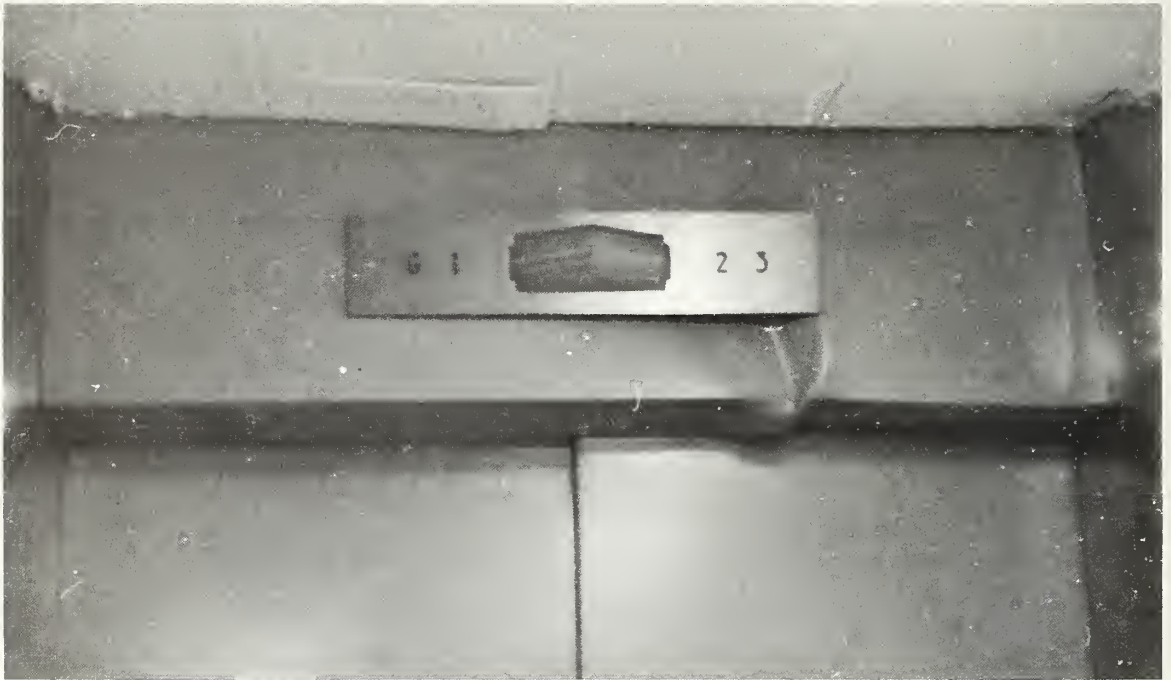
Figure 5.84 Buckled steel elevator door frame in the Pacoima Hospital.

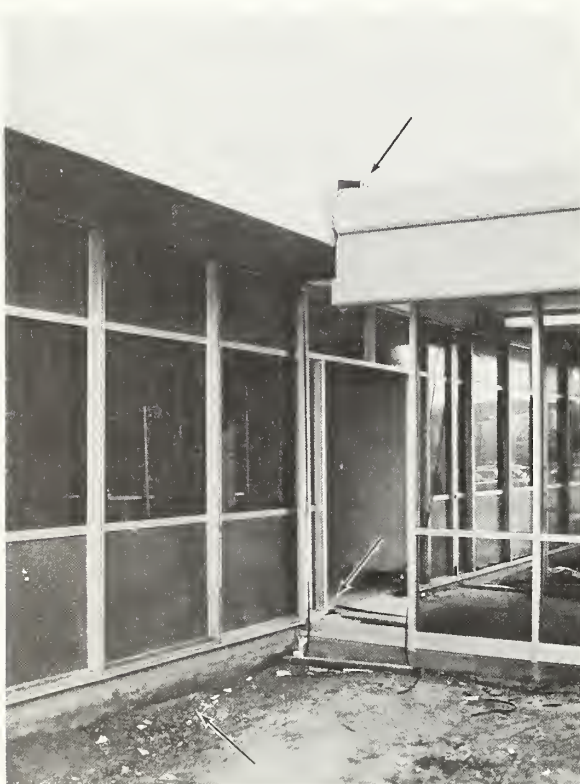
The walkway shown in figure 5.85 connected the north section with the mental health center. Relative movement shown seemed to indicate uplift of the main building. Further relative movement is shown in figure 5.86 which shows the north side of the north section. It was not certain at the time if the displacement was due to building uplift or soil settlement. Later reports indicated that the pile caps had "jumped" off the piles.

Figure 5.85 Connecting enclosed walkway between Pacoima Hospital (on the left) and the Mental Health Center. The structural damage and ground condition (arrows) appeared to indicate that the hospital building had experienced several inches of uplift.

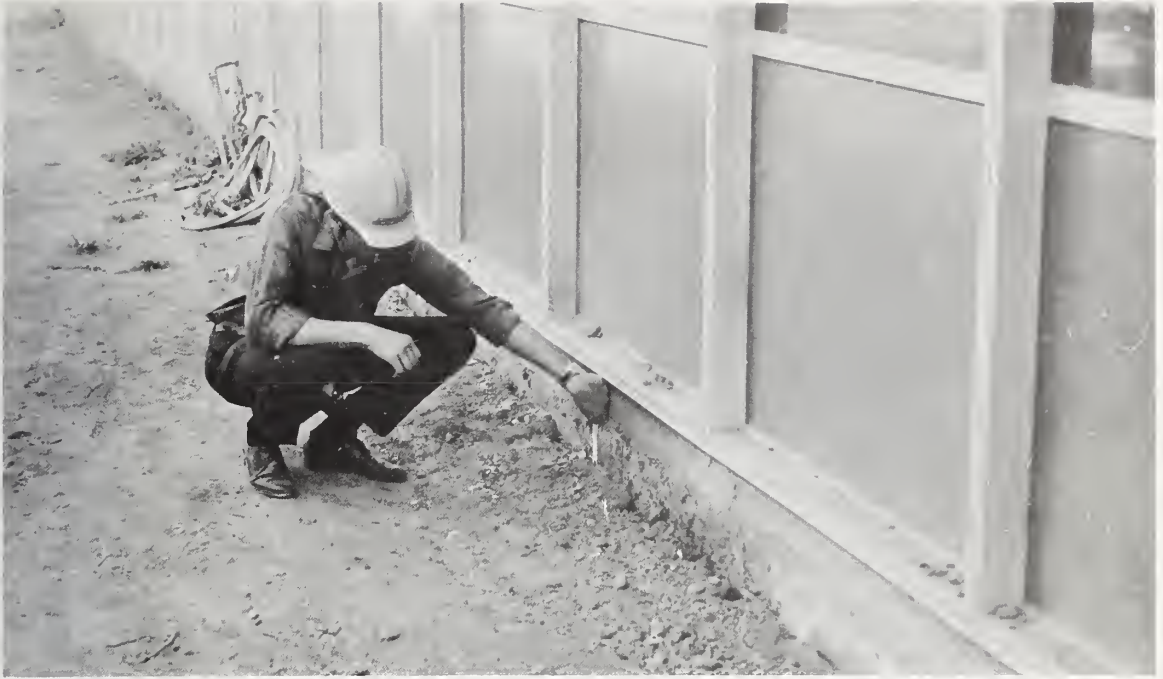
Figure 5.86 Relative movement between north section and ground.

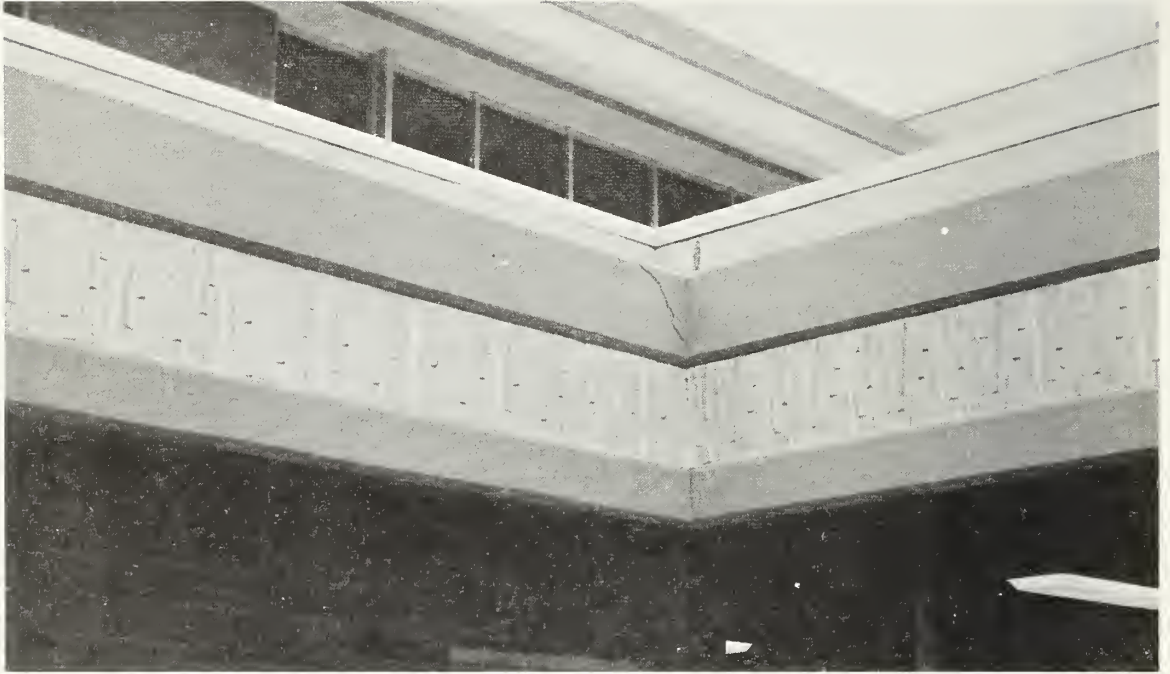
The west elevation of the new two-story mental health center is shown in figure 5.87. Interior finishing was being rapidly completed so that this reinforced brick masonry building could be used as a general purpose facility. Damage to shear walls and other structural elements was minor as indicated by the cracking shown in figure 5.88.

Figure 5.88 Cracking in exterior roof beams of the Mental Health Center.

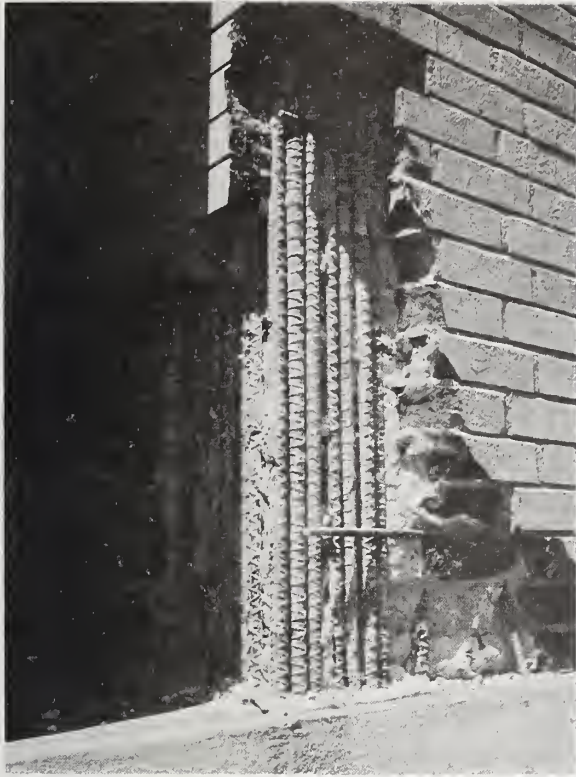
The aftershock of March 31 (refer to section 1.1) caused additional damage to the brick veneer. Although the magnitude of this aftershock was small (4.0 on the Richter scale), because the epicenter was only three and a half miles away from this structure, the resulting damage to the exterior cladding was considerably greater than that caused by the February 9 quake. During the aftershock large pieces of the brick veneer were spalled off from the wall, exposing the reinforcement in the shear wall (fig. 5.92). The building, however, remained in full use after both the February 9 earthquake and the March 31 aftershock.

Figure 5.92 Additional damage to brick veneer resulted from the March 31 after-shock, exposing the reinforcement in the shear wall.

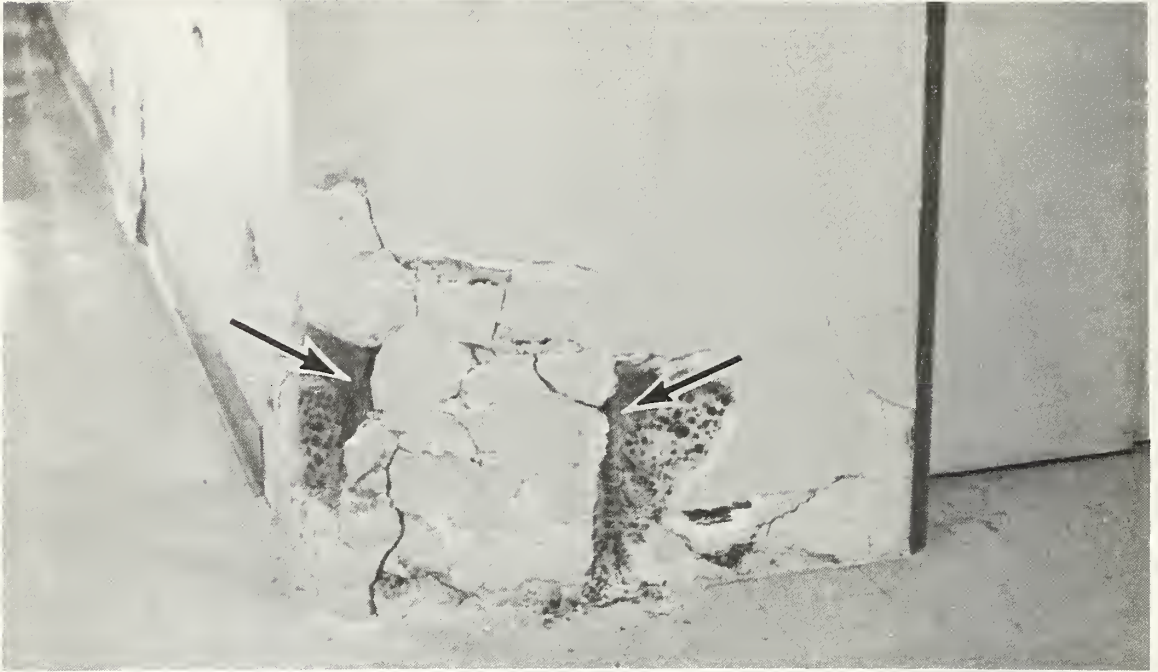
There was severe cracking of the shear walls in the first, second, and third stories (fig. 5.96). The doors to the interior stairwell on the second and third floors were rendered inoperable due to the crushing of the spandrel beam in the shear wall (fig. 5.97). The fourth-floor slab, which is the transfer slab between the circular tower shear walls and the walls below, cracked and displaced vertically. There

Figure 5.96 Crushed reinforced concrete elevator shaft on the first floor. Note the exposed reinforcing steel. (See fig. 5.94, location 1).

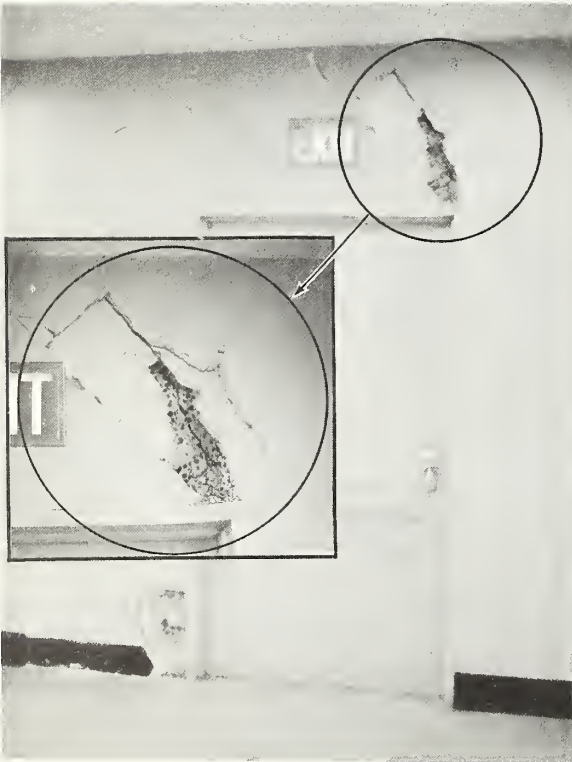
Figure 5.97 Second-floor door to interior stairwell. This door was jammed shut.

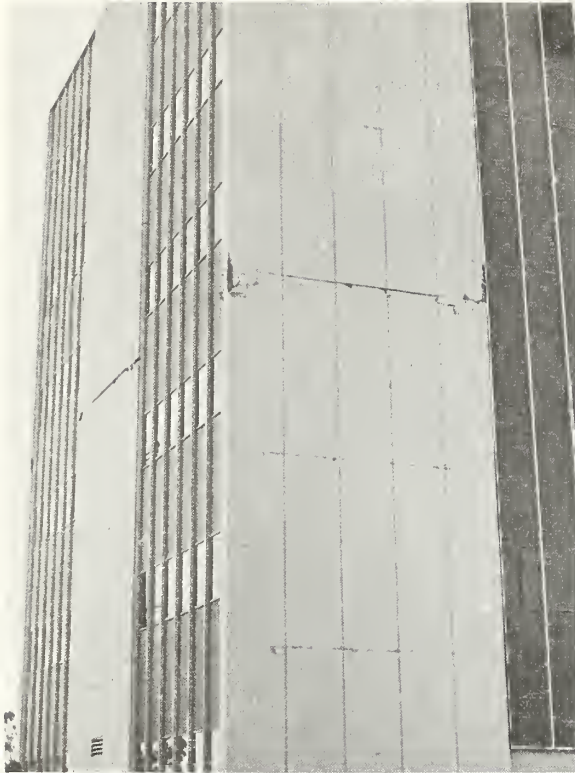
There was horizontal cracking at the construction joint at each floor level as shown in figure 5.100. This was particularly pronounced at the second, third, and fourth floors where concrete also spalled at the corners (figs. 5.101, 5.102, 5.103, and 5.104). Note the buckled vertical reinforcement in figure 5.104. These same shear walls were also cracked diagonally for the full height of the building (fig. 5.102). There was also extensive crushing at the base of the southeast shear wall as shown in figure 5.105.

Figure 5.100 View of the northeast corner. The north and east shear walls were cracked horizontally at the second through the sixth floors. Diagonal cracks were also present between floors.

The structure was repaired by attaching new 8-in gunite walls to the existing shear walls and providing additional floor-slab support by means of steel angles.

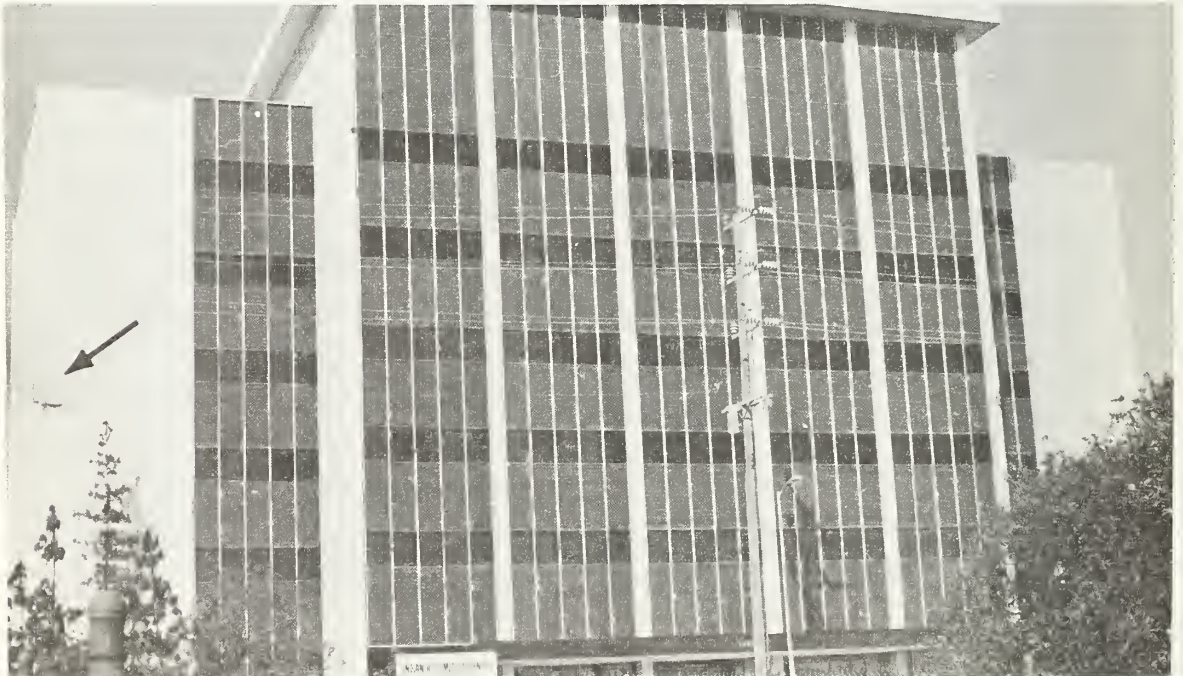
Figure 5.101 South elevation of the Indian Hills Medical Center. Note the horizontal crack and spalling visible on the left shear wall at the fourth-floor level.

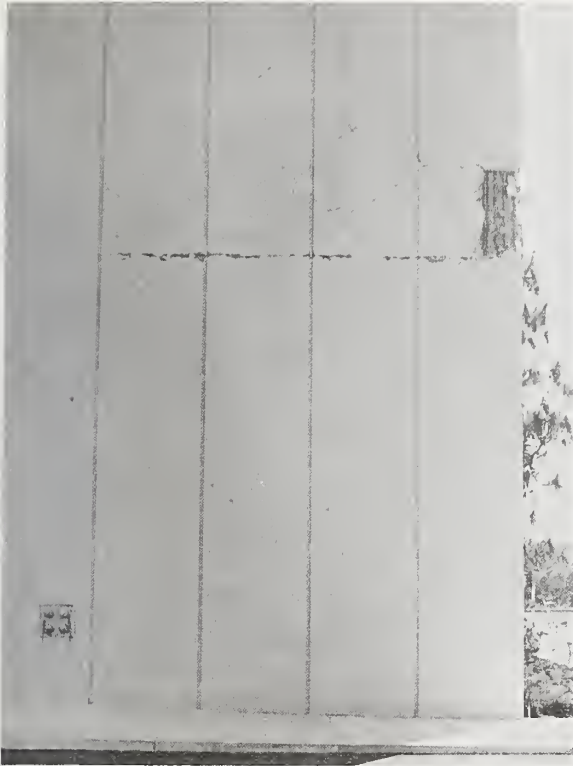
Figure 5.102 Diagonal cracking and spalling in the northwest corner shear wall.

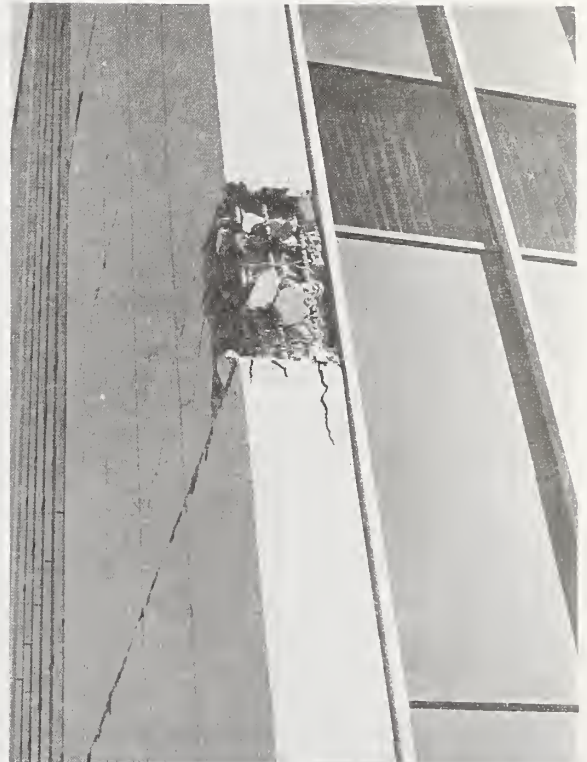
Figure 5.103 Close-up view of the spalled area of the shear wall shown in figure 5.102.

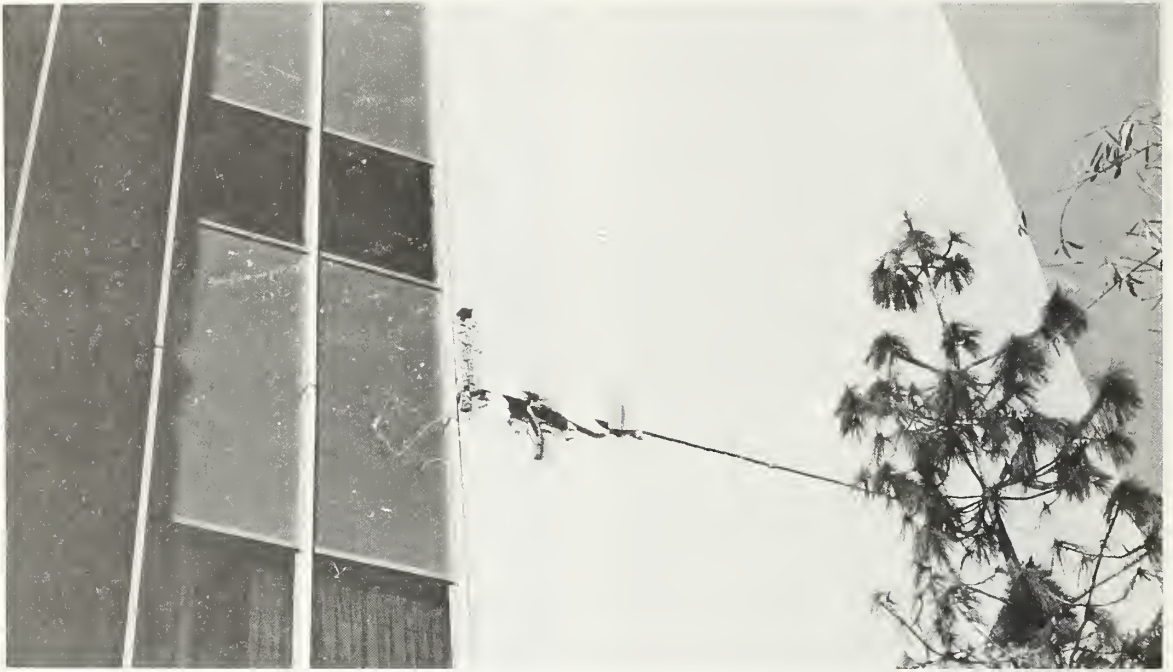
Figure 5.104 Buckled vertical reinforcement in southeast shear wall.

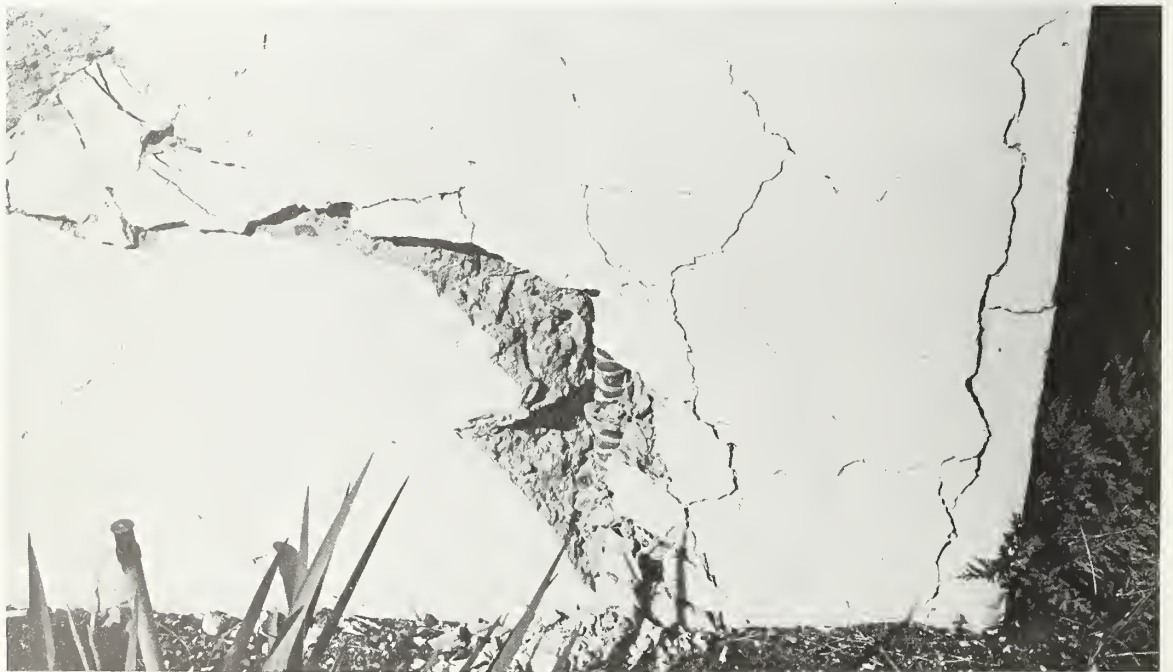
Figure 5.105 Cracking at the base of the southeast corner shear wall. Note the exposed reinforcing bar.

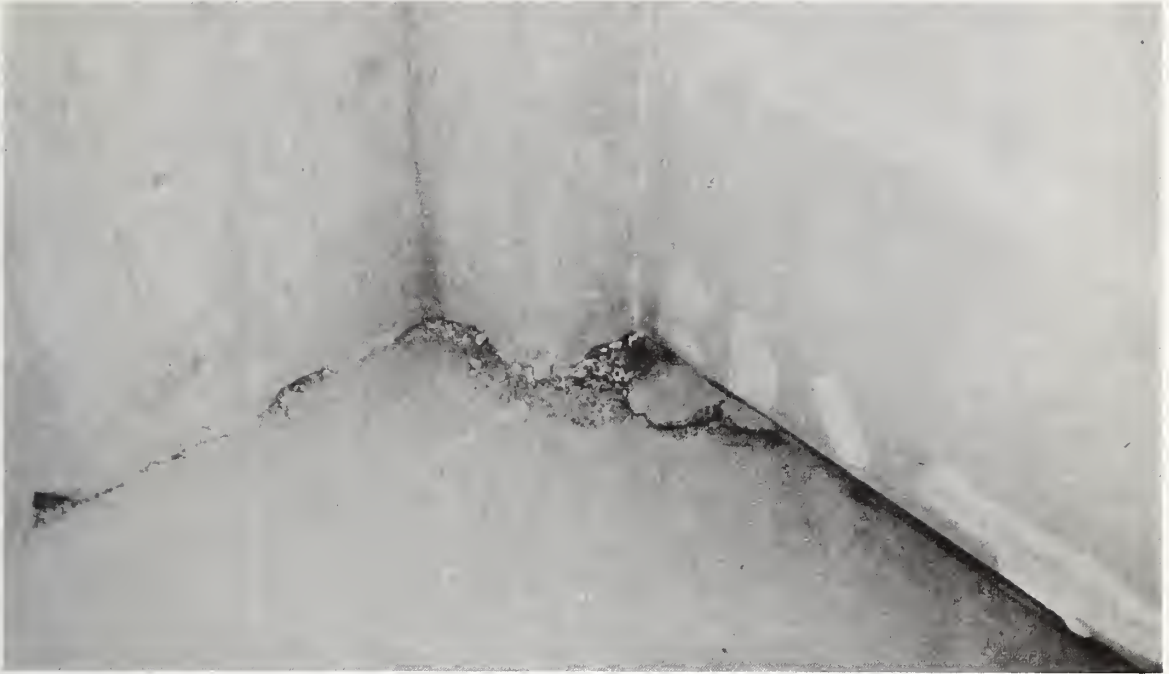
Interior damage consisted of horizontal cracking at the floor-to-wall joint of the third, fourth, and fifth floors (fig. 5.106). There were also damaged beam-column connections on these same floors (fig. 5.107). Some damage was also noted in the stairwell where the connections of metal stairs

Figure 5.106 Interior view of horizontal cracking at the northeast corner of the fourth floor.

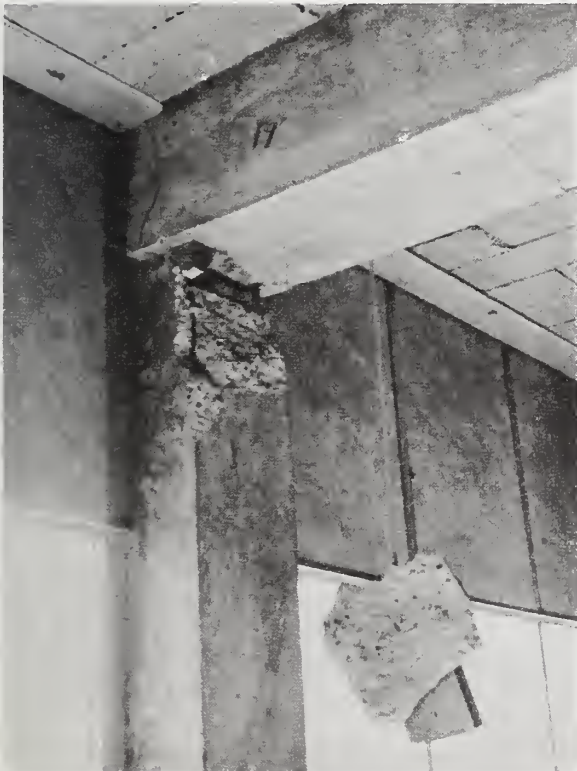
Figure 5.107 Damaged beam-column connection in the fourth story. The large piece of broken concrete is suspended by an electrical cable.

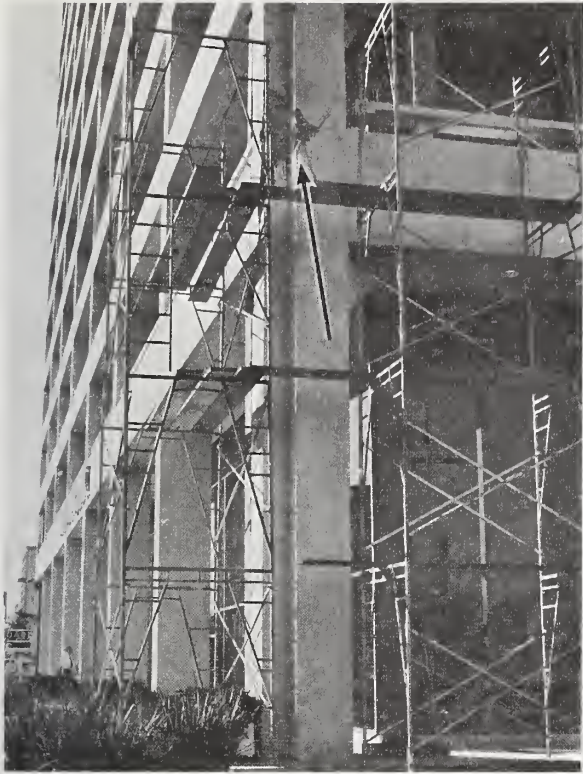
An elevation of the bank building is shown in figure 5.113. Principal structural damage was in the first-story columns, primarily at the second-floor beam-column connections as shown in figure 5.114. These columns were repaired with epoxy shortly after the earthquake as shown in figure 5.115. However, the initial attempt was not successful and two additional trials were made before the repair was considered to be acceptable.

Figure 5.114 View of cracked southeast column.

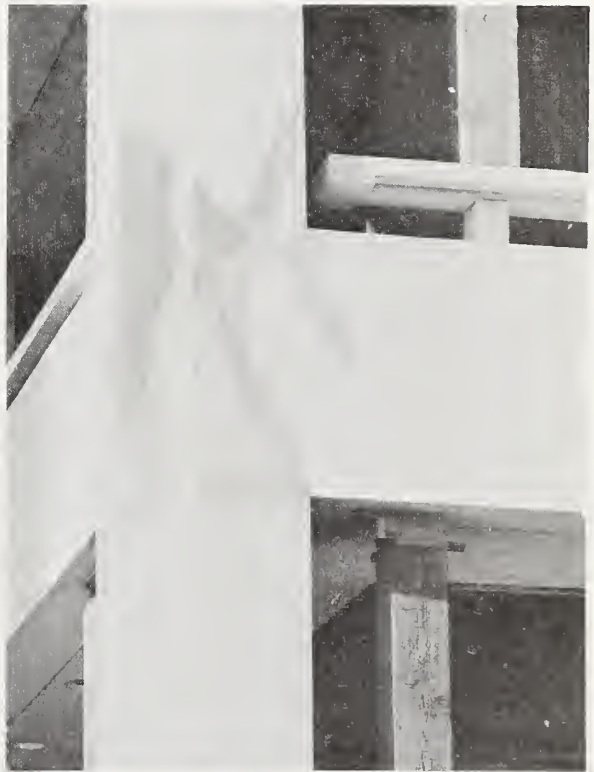
Figure 5.115 Cracked beam-column connections at the first floor were repaired with epoxy.

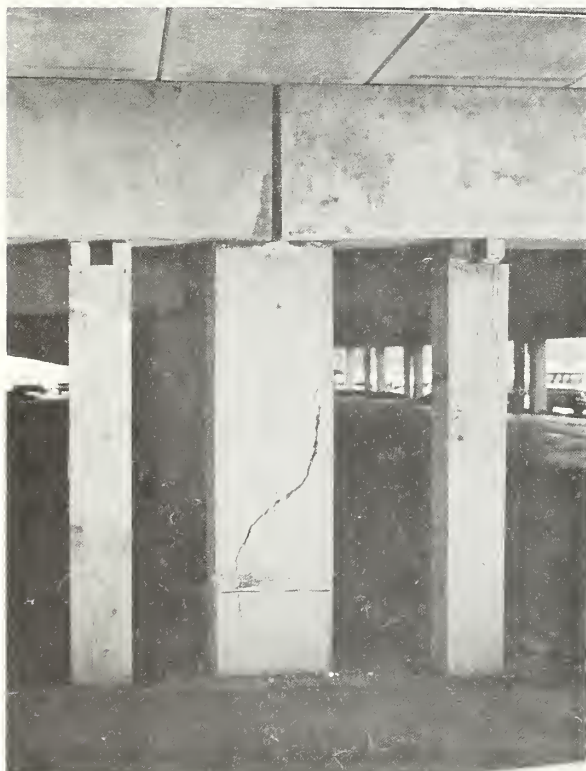
The parking garage located on the north side of the bank (see fig. 5.111) is shown in figure 5.116. The garage was constructed of precast pretensioned hollowcore planks with a cast-in-place topping supported on precast pretensioned girders. Columns are cast-in-place reinforced concrete. Most damage was limited to the columns which were cracked on the east-west faces as shown in figure 5.117. Concrete column corbels were also cracked as shown in figure 5.118.

Figure 5.117 Typical cracked interior column. All beams with damaged columns were shored with timber posts.

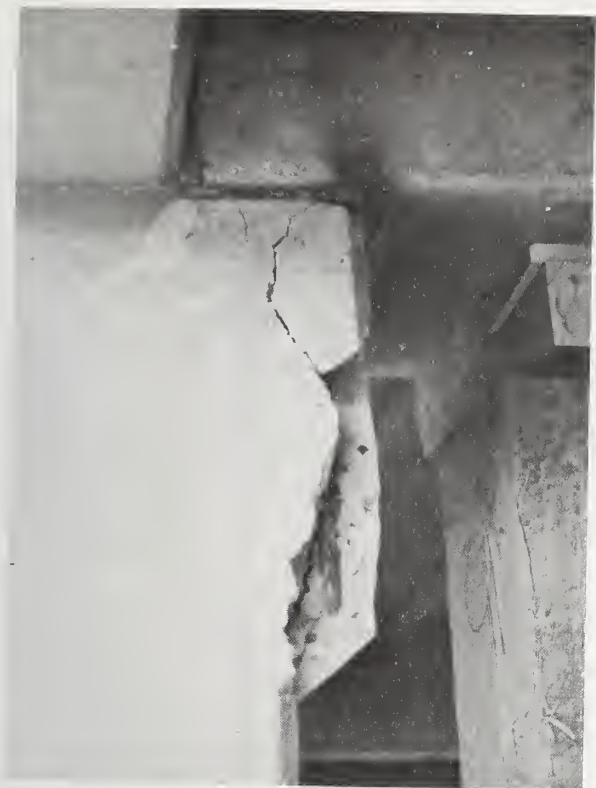
Figure 5.118 Cracking of exterior column corbel.

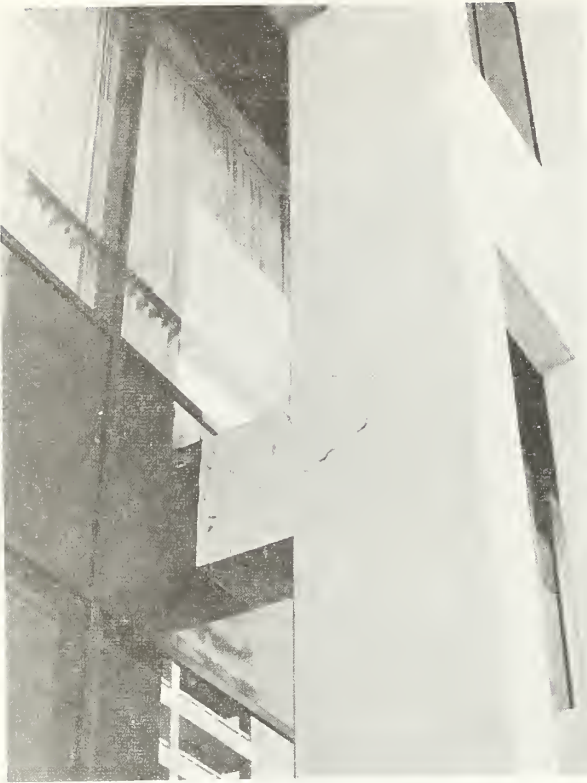
There were cracks in the building frame over most of its height. These were especially pronounced in the connection of the lightweight concrete beams to the normal weight concrete

Figure 5.121 Cracking in a beam-column joint at the second floor level on the north face of the Bank of California building.

columns as shown in figure 5.121. This damage was being repaired with epoxy.

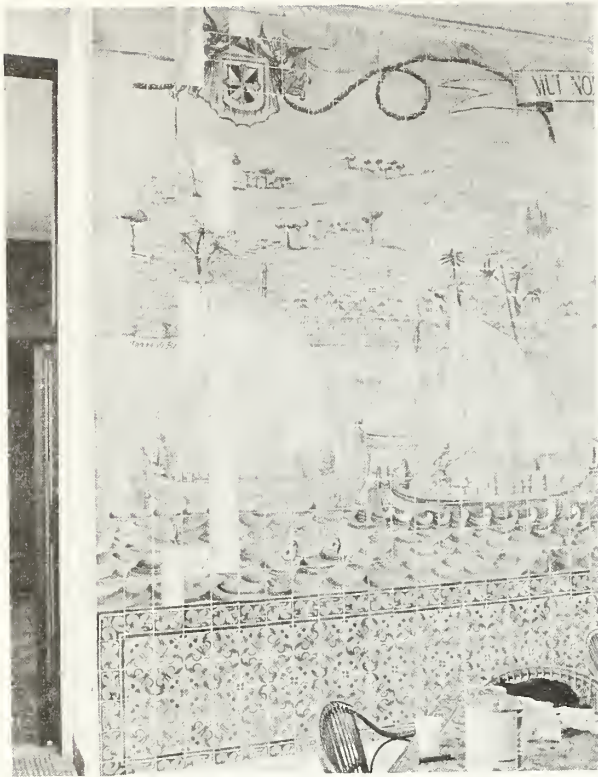
The 21-story Sheraton Universal Hotel, figure 5.124, is a reinforced concrete building located at 3838 Lankershim Boulevard. This 210-ft building was designed under the Los Angeles Code using the November 1966 modifications for a ductile moment-resisting frame. The floor plan of the high-rise portion is shown in figure 5.125. A cross section through the main building and a typical beam-to-column framing detail is shown in figure 5.126a and b, respectively. Apparent damage to this concrete structure was limited to a cracked mural as shown in figure 5.127.

Figure 5.127 Cracked tile mural.

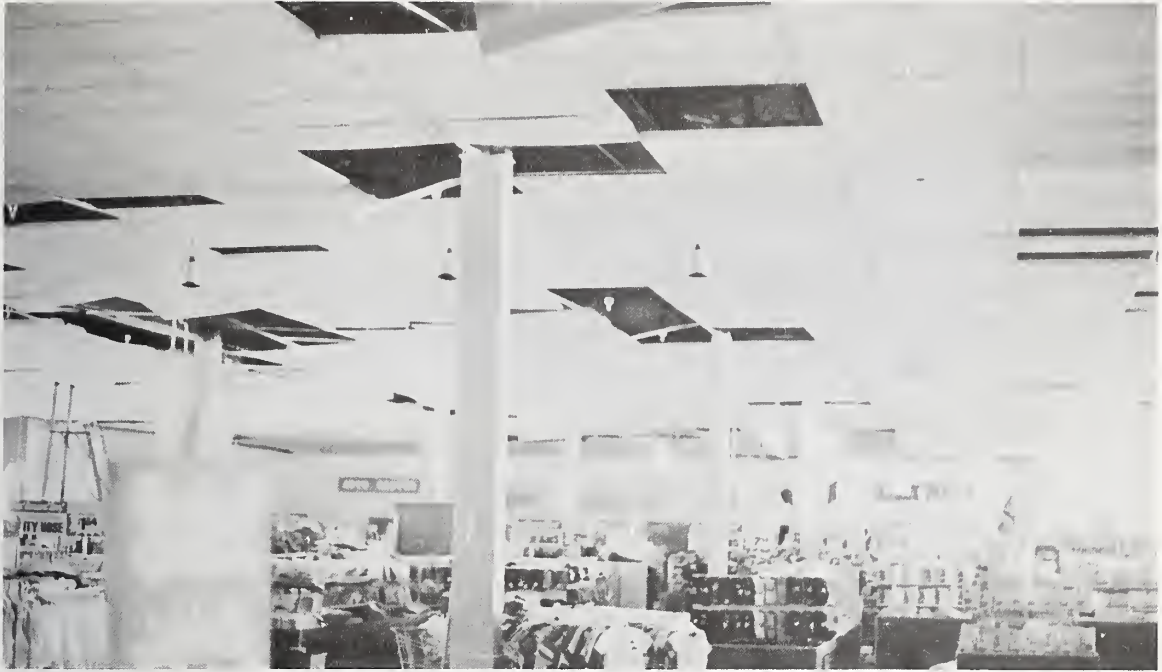
Other interior damage consisted of fallen suspended ceiling and merchandise thrown to the floor (fig. 5.130).

Figure 5.130 Interior view of Grants Department Store showing missing portions of suspended ceiling. Most of the merchandise which had been thrown to the floor had been picked up when this photograph was taken.

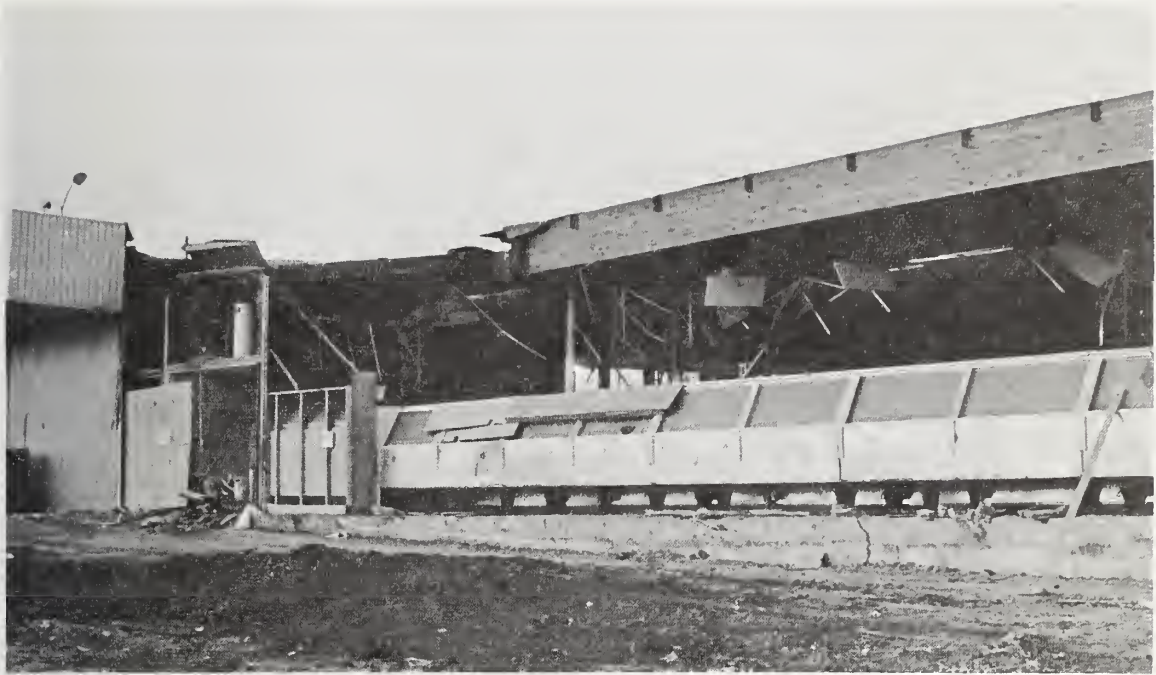
Grant's Department Store (location 2) except damage was more severe. At this site the masonry wall supporting wood beams fell outward, dropping beams to the ground. The laminated wood girder which supported one end of the roof beams is visible in figure 5.132.

Figure 5.132 View of the Boy's Market looking east. Most debris has been cleared.

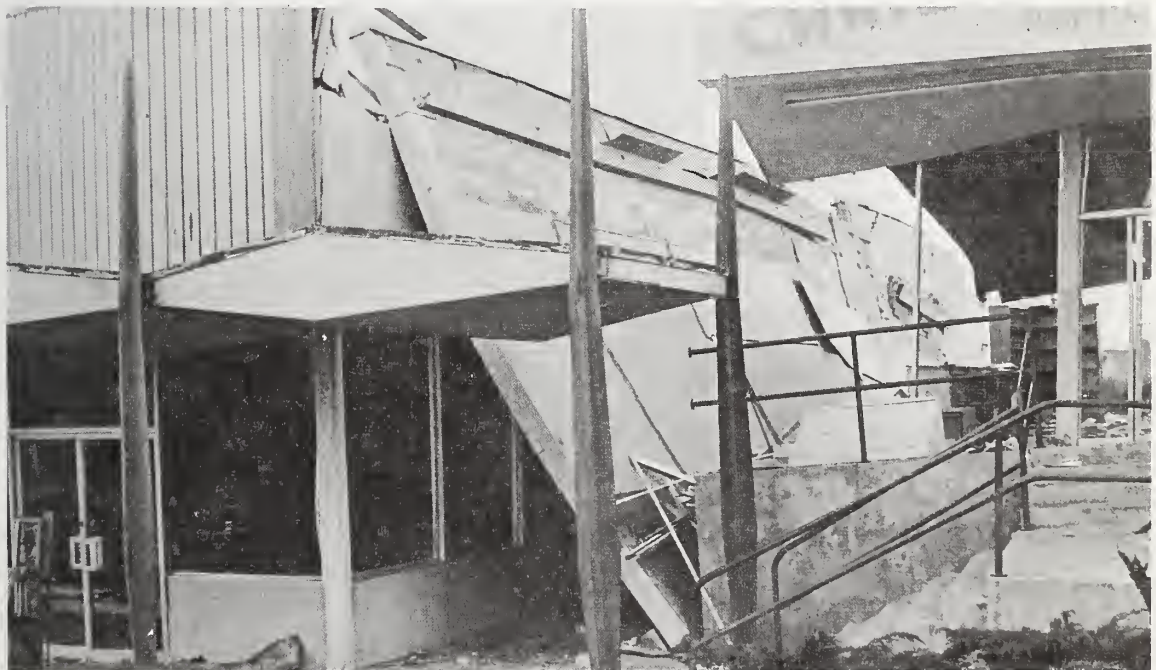
Another small store in the center was similarly damaged as shown in figure 5.133. Note that the reinforced brick masonry wall remained essentially intact even though it fell against an adjacent building. A view from the opposite end of the store is shown in figure 5.134. The laminated timber beam at the left spanned approximately 65 ft from a column at the front of the store to a rear masonry wall which also collapsed. Wood joists spanned from this beam to a wood ledger fastened to the wall on the right. Another view of this store is shown in figure 5.135.

Figure 5.133 Collapsed side wall of a small store in the shopping center.
